**DELAWARE RIVER BASIN
TONICKON CREEK, BUCKS COUNTY**

**PENNSYLVANIA
ID NO. PA.00734**

**NOCKAMIXON STATE
PARK DAM**

**PHASE I INSPECTION REPORT
NATIONAL DAM INSPECTION PROGRAM**

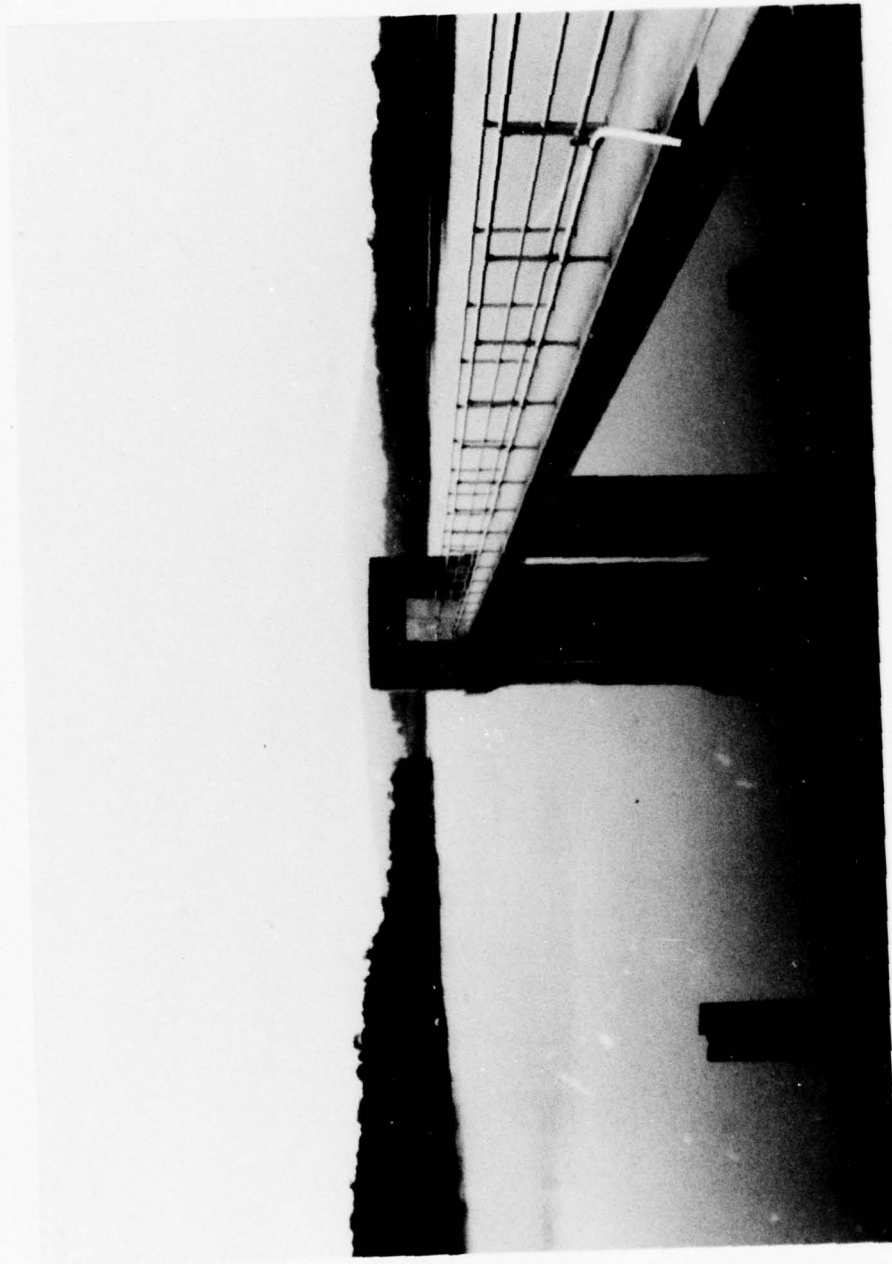
VIEW OF PRINCIPAL INTAKE STRUCTURE, NOTE
STAFF GAGE ON WALL OF TOWER.

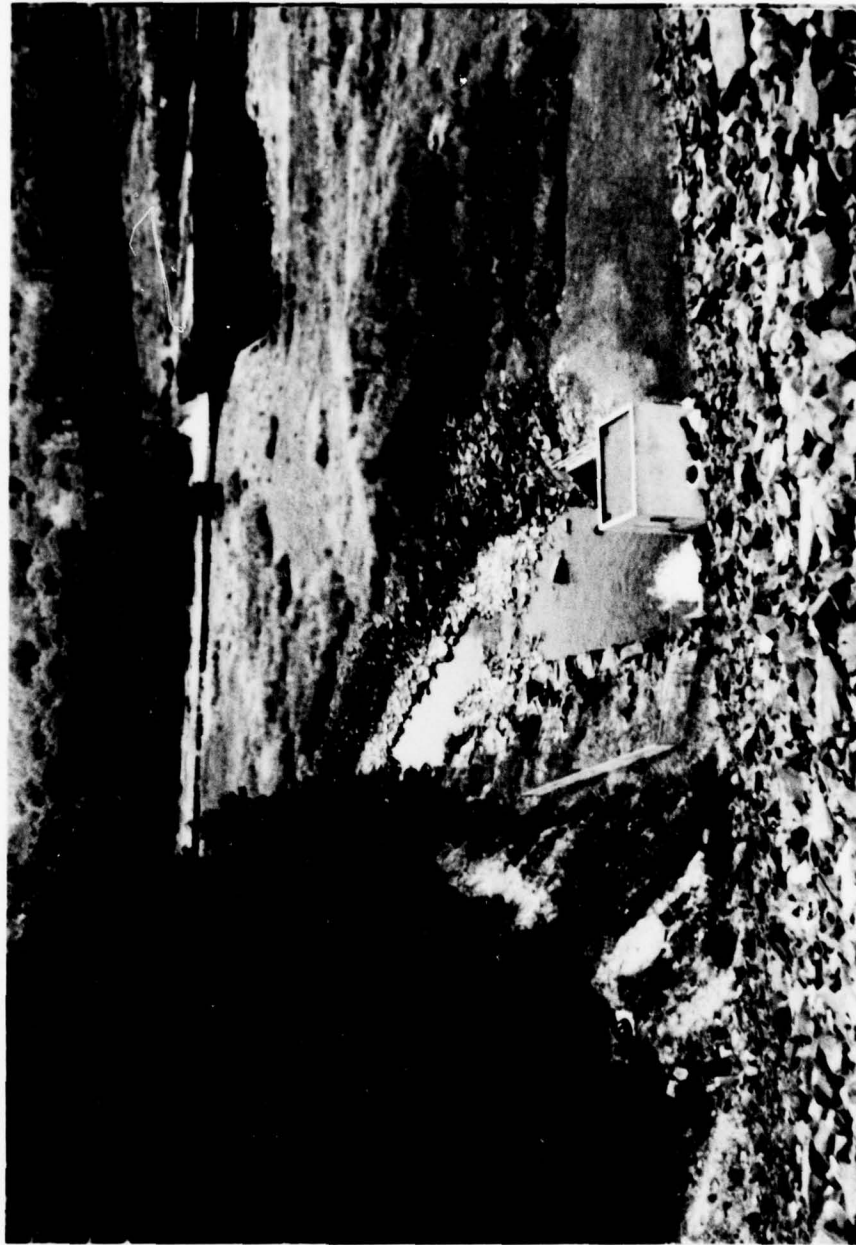
VIEW FROM DAM CREST OF PRINCIPAL OUTLET STRUCTURE AND
DOWNSTREAM CHANNEL. THE EMERGENCY SPILLWAY IS ON THE RIGHT.
WHITE WATER IN CHANNEL IS THE OUTLET FOR LOW FLOW REQUIREMENTS.

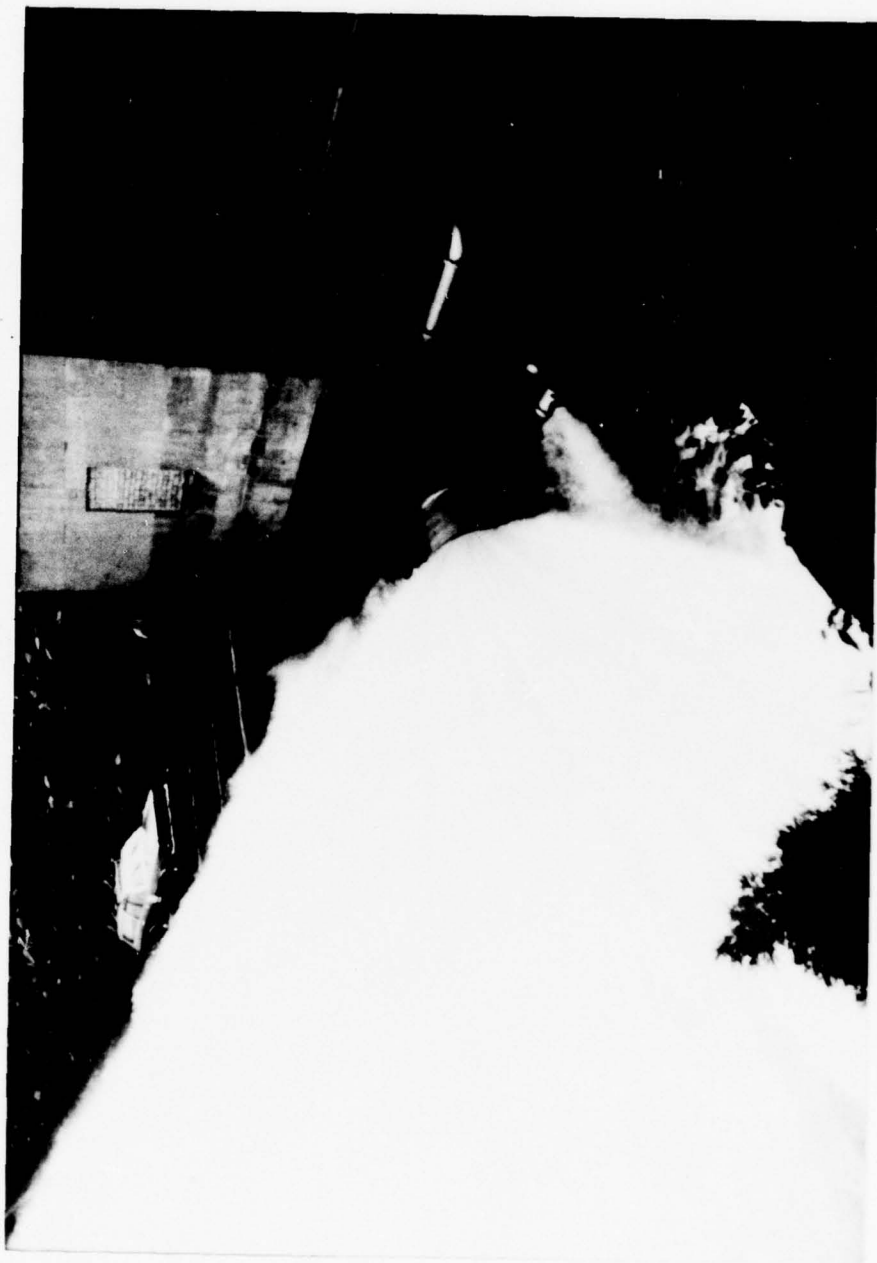
FIXED CONE DISPERSION VALVE AND LOW FLOW PIPE IN
FULL OPERATION AT PRINCIPAL OUTLET STRUCTURE. THE
CONTROL HOUSE CONTAINS THE PIEZOMETER INSTRUMENTATION
READOUT PANEL.

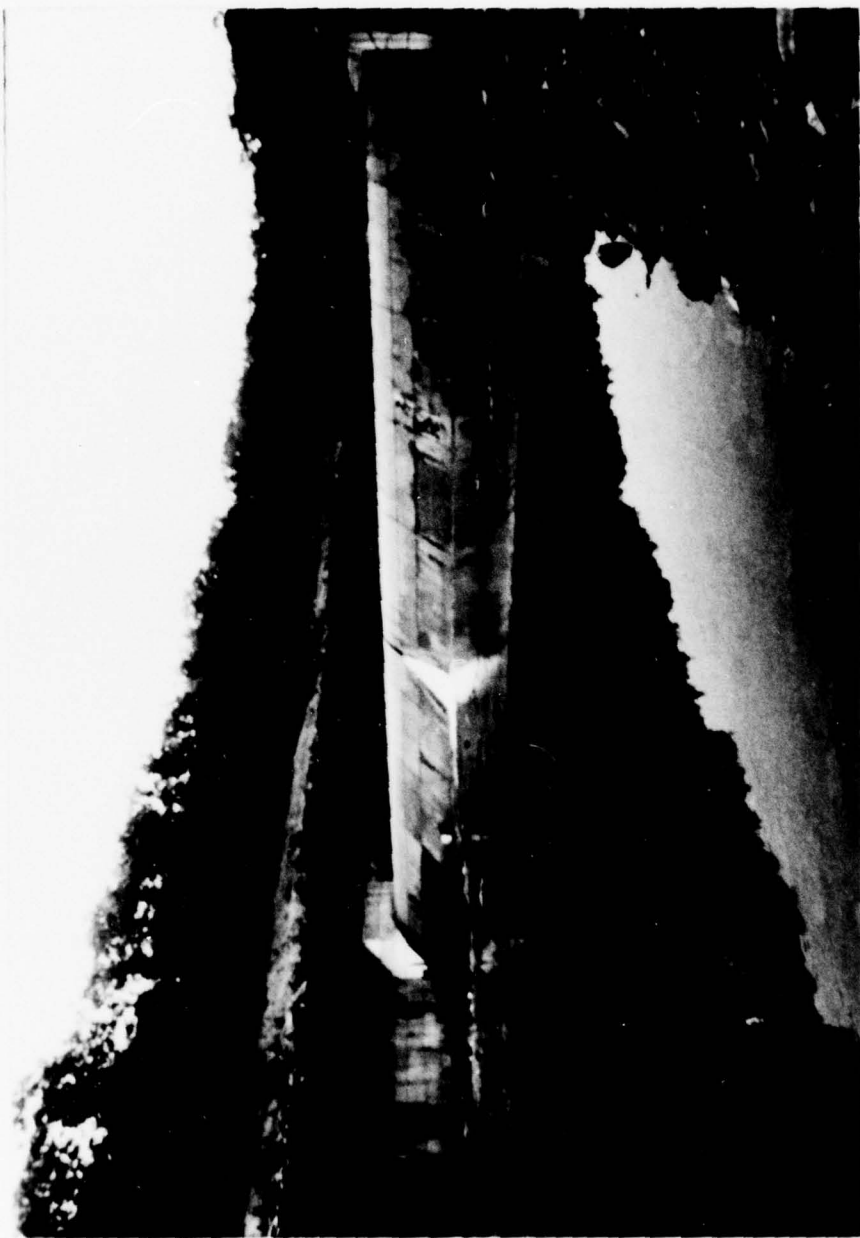
OVERFLOW WEIR OF EMERGENCY SPILLWAY STILLING BASIN.
SPILLWAY CAN BE SEEN IN "OVERVIEW" PHOTOGRAPH.
